Intel[®] Xeon[®] Processor 7500 Series

Specification Update

March 2015

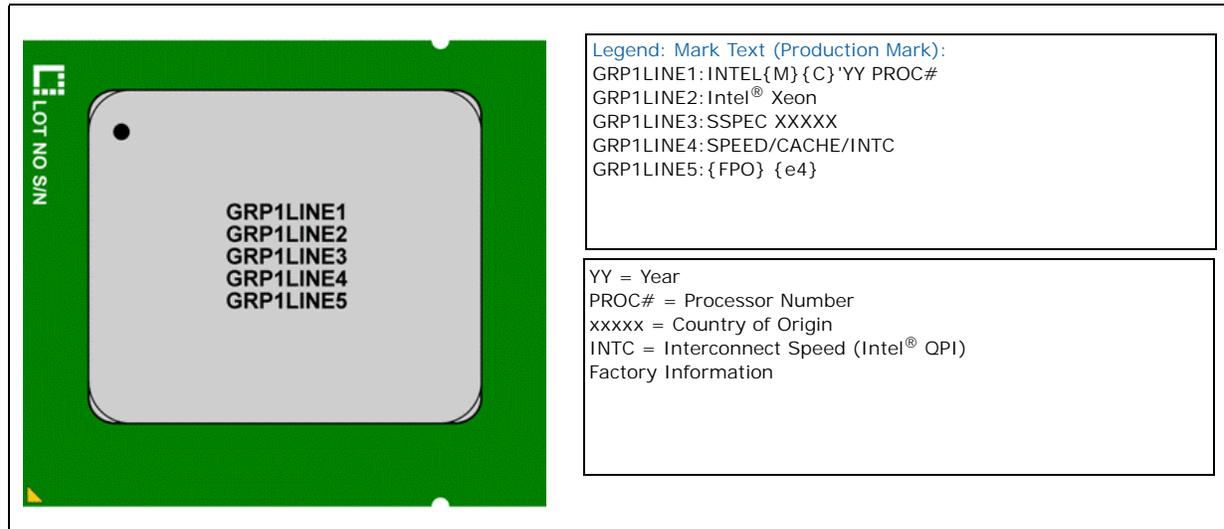
Figure 1. Processor Top-Side Marking (Example)

Intel® Xeon® Processor 7500 Series stepping can be identified by the following component markings:
